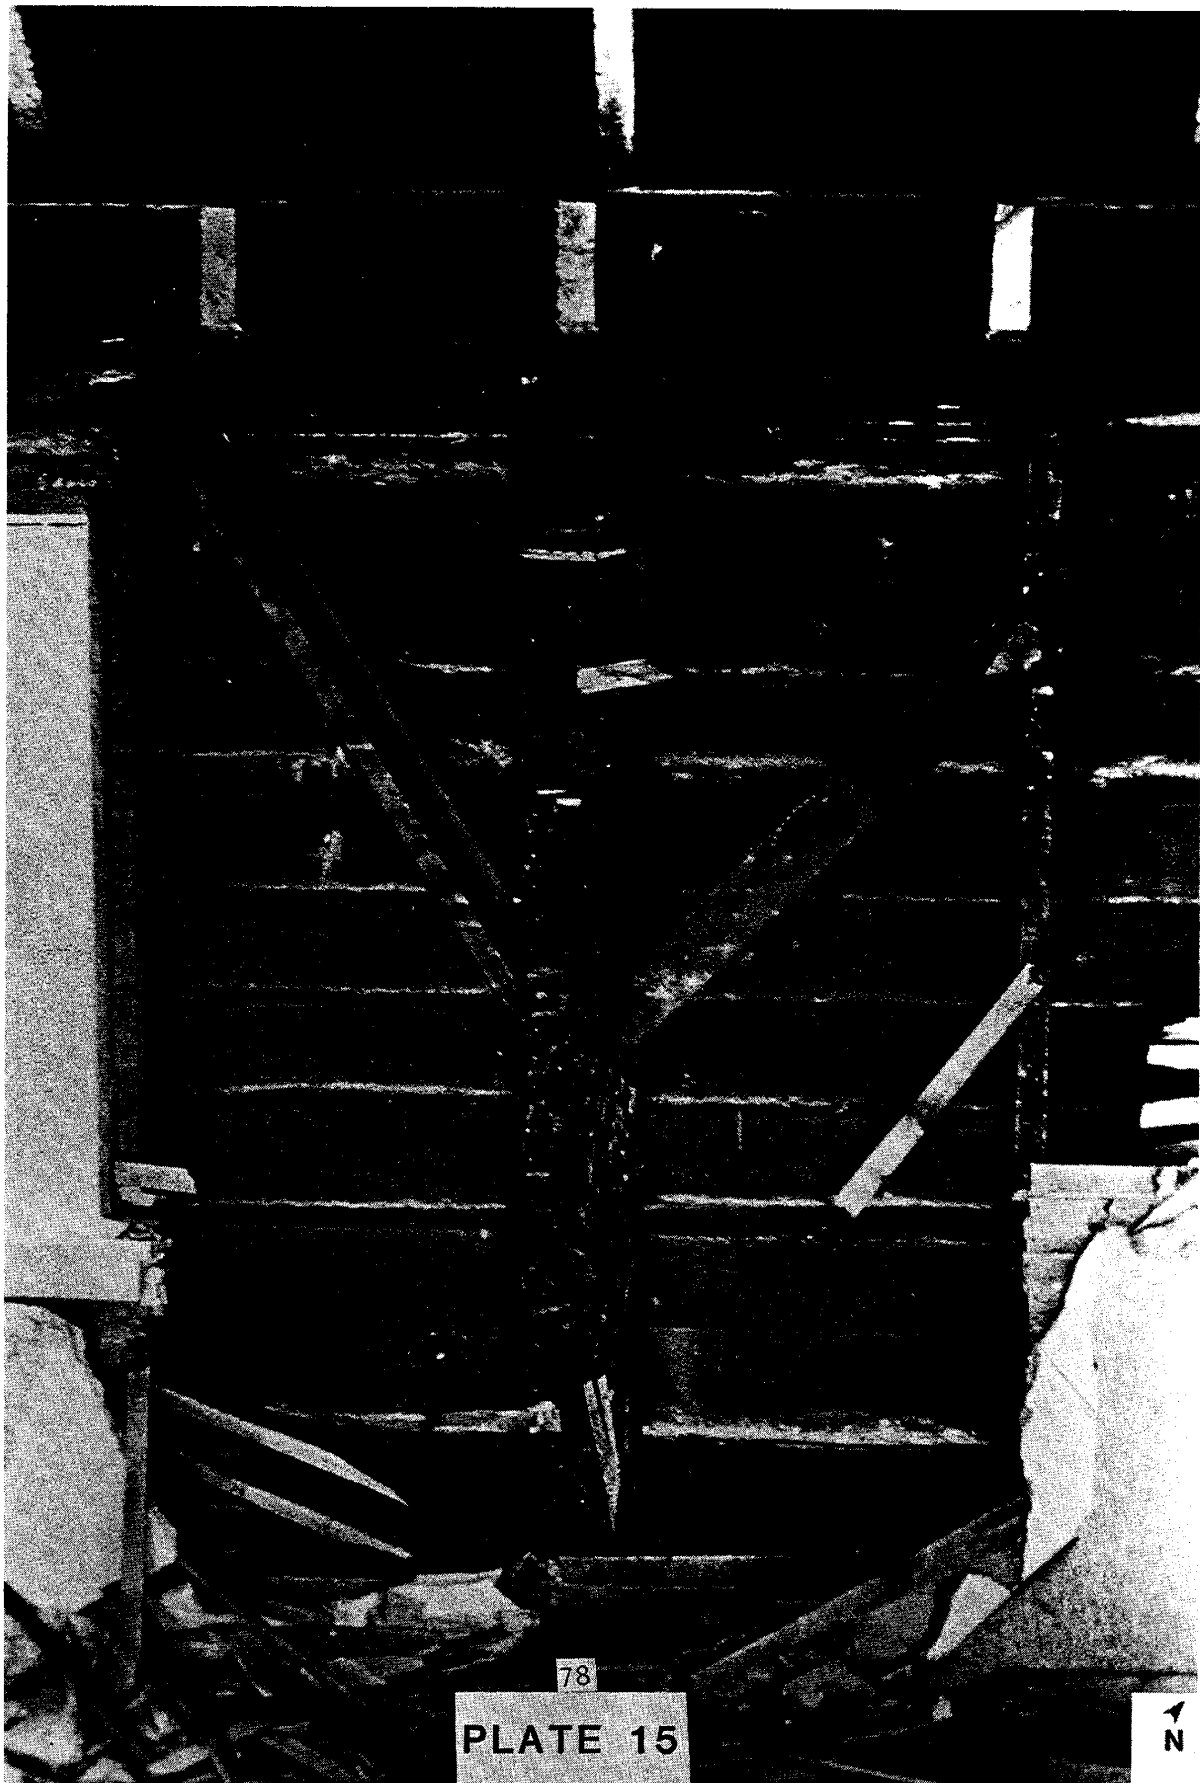
PLATE 15

INTERIOR NORTH WALL OF WEST SECTION, SECOND FLOOR  
(SAME DETAIL ON FIRST FLOOR AND ON SOUTH WALL AT CENTER OF BUILDING)

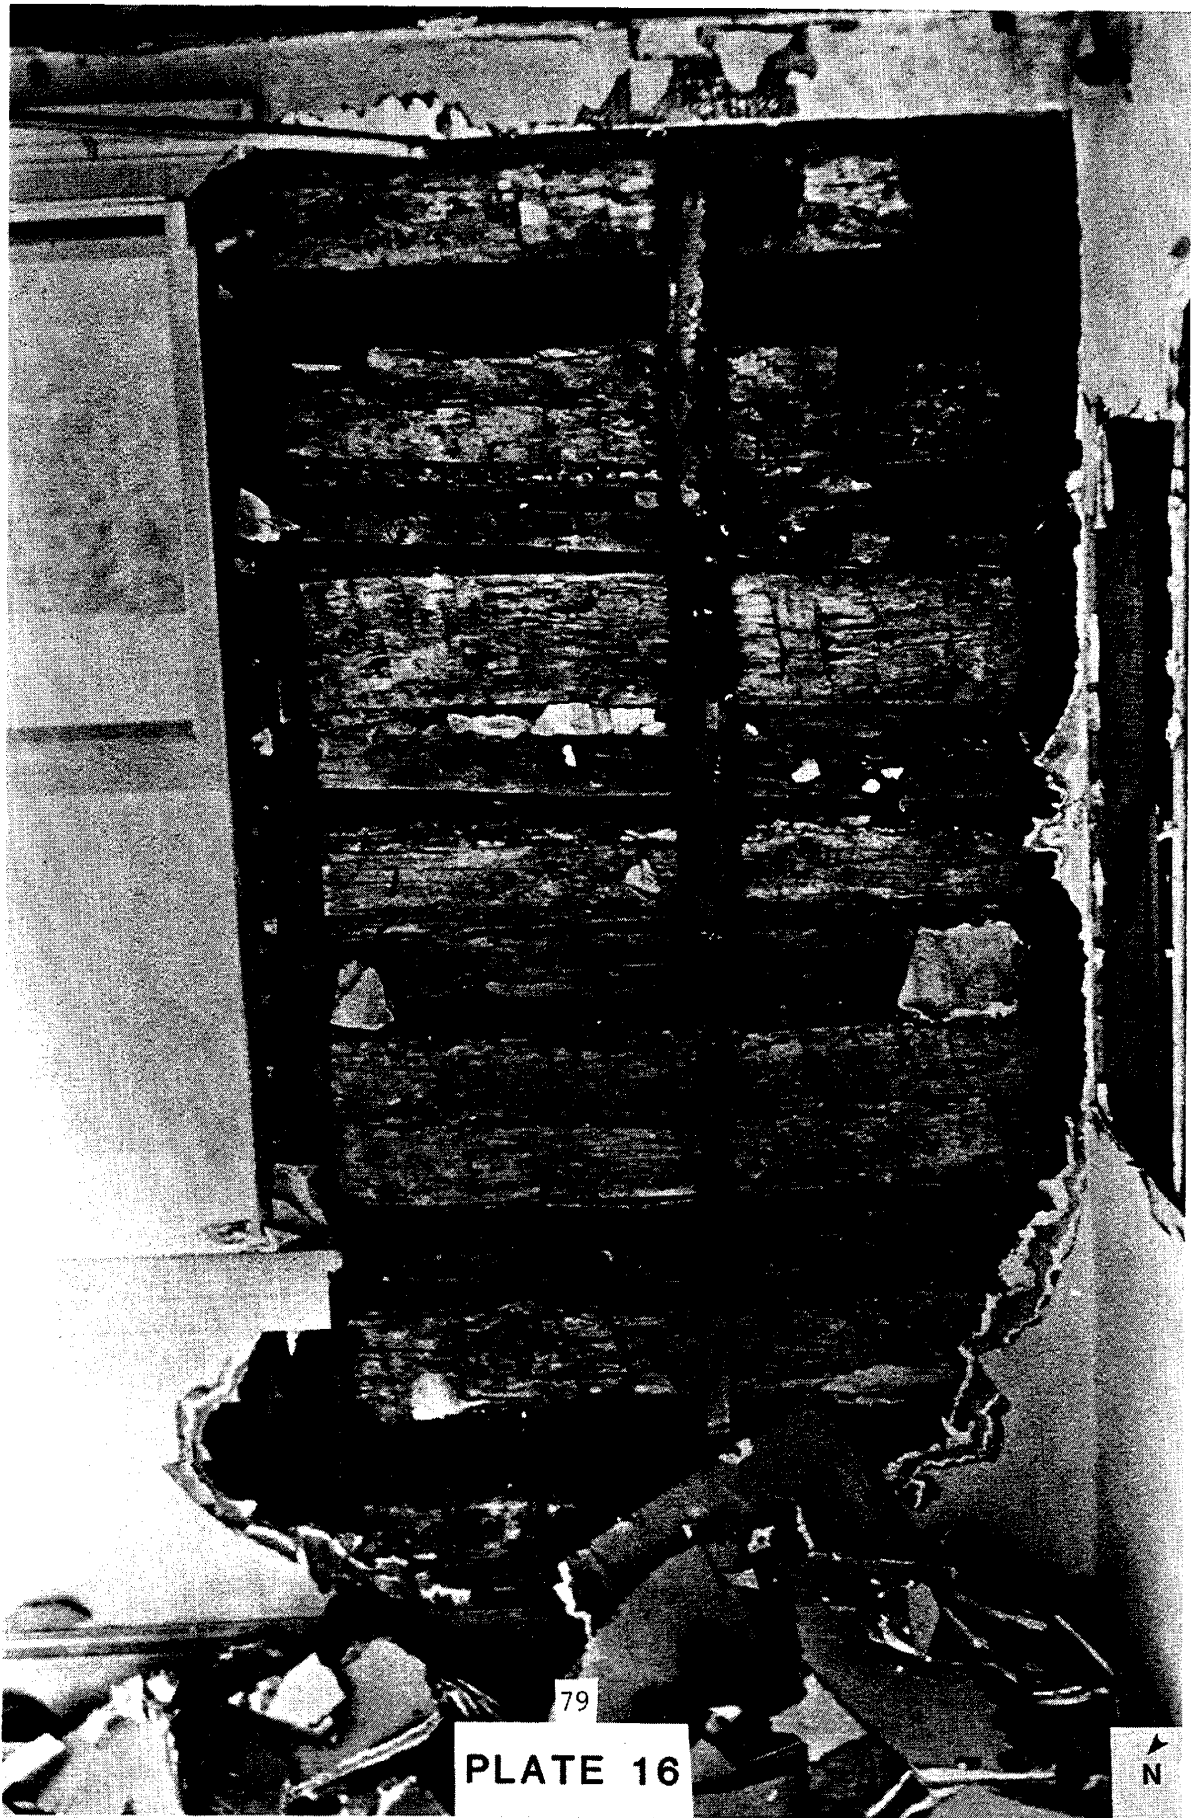
INTERIOR SOUTH WALL OF CENTER SECTION, FIRST FLOOR

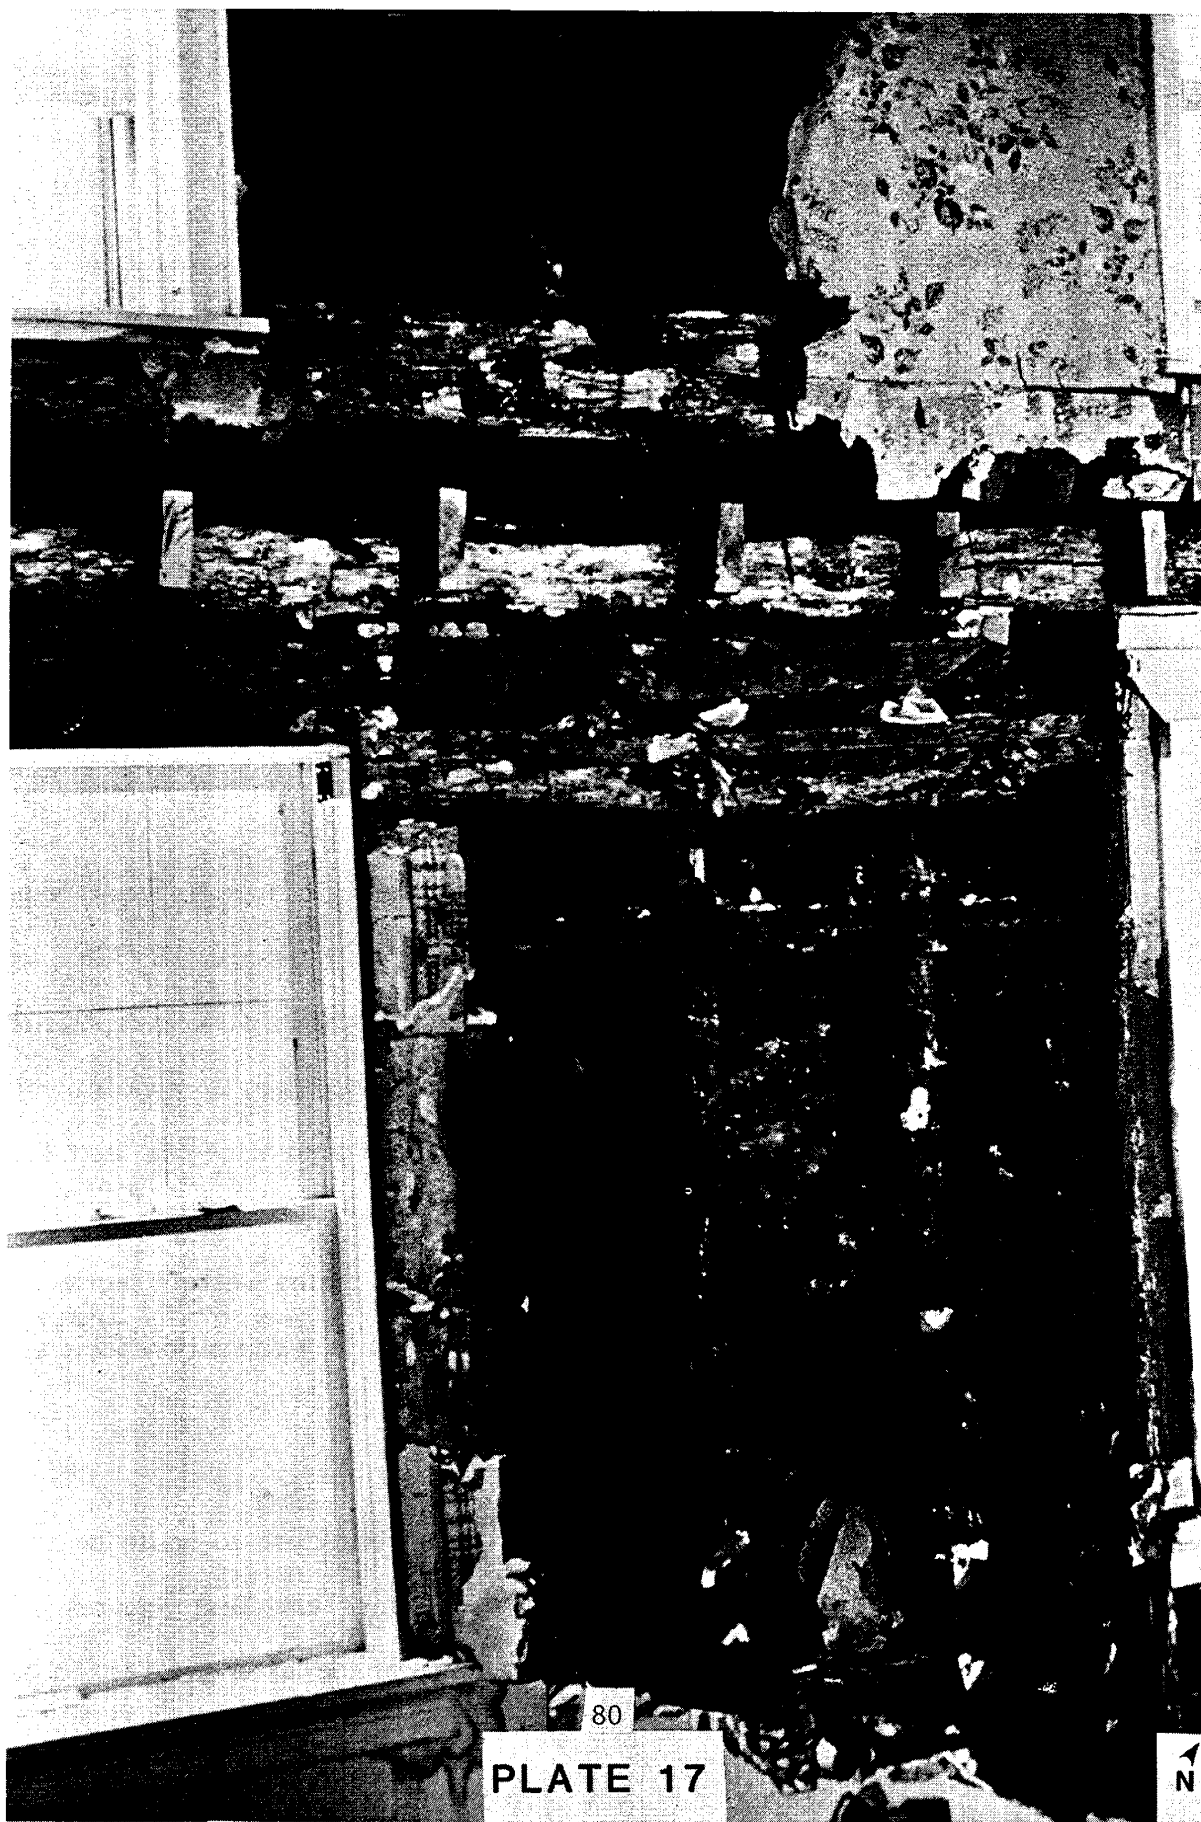
PLATE 17

INTERIOR NORTH WALL OF CENTER SECTION

An examination of the interior walls of the structure also showed differing construction techniques and materials in the west and center sections. The framing of the west section consisted of a braced-frame design with 3 ¾ in. x 7¼ in. dimension main vertical members (Plate 15). The internal framing of the north wall of the central section made use of a combination of horizontally positioned logs, obviously salvaged from a prior use, braced by various techniques (Plate 16). The south wall revealed the more traditional technique of reused logs serving as major load-bearing members with a vertical stud support system present elsewhere (Plate 17).
